Arlington Reservoir Master Plan

2018

INTRODUCTION AND EXECUTIVE SUMMARY

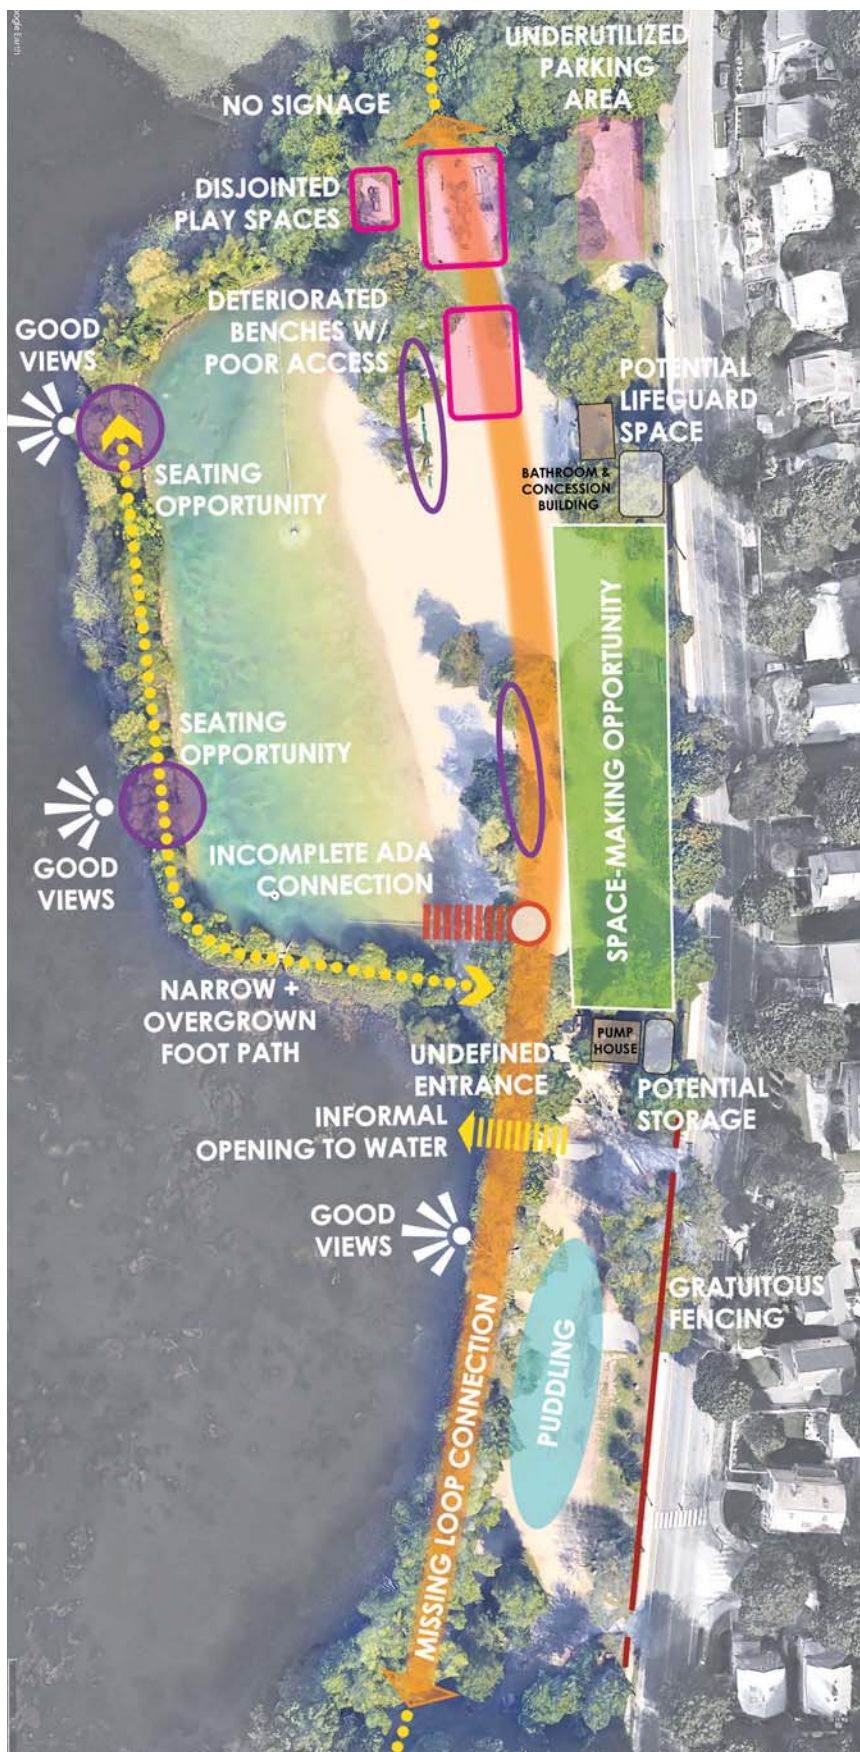
Analysis diagram of the beach and parking area, showing trail conditions, incomplete or non-compliant walking path connections, seating and viewing opportunities, deteriorated perimeter fencing and disjointed programmatic elements

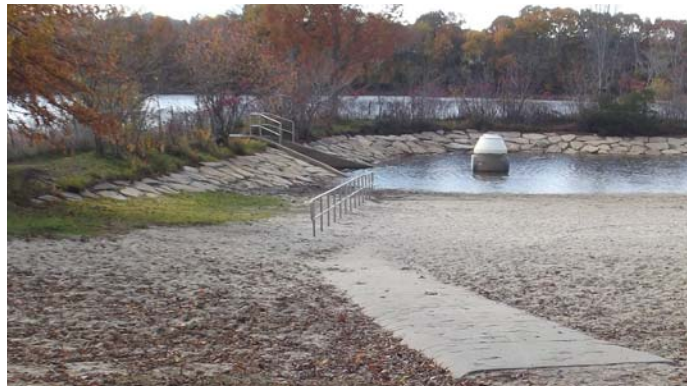
Non-ADA compliant concrete pathway and handrail system in foreground; the berm in background.

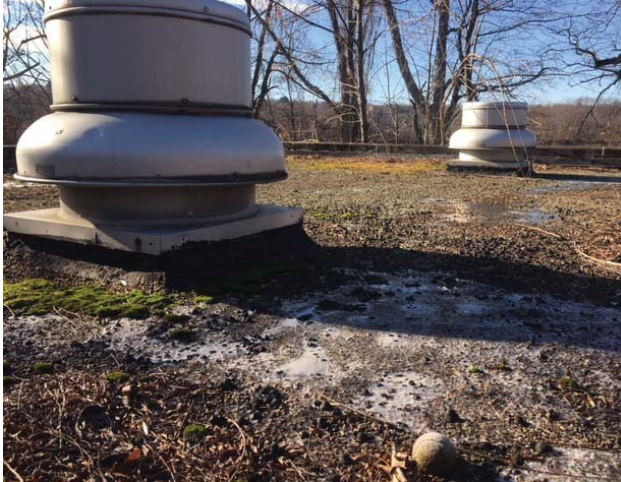
Roof - The roof assembly consists of a built-up tar-and-gravel membrane over a metal deck. It is not known if any thermal insulation or vapor retarder is present in the roof system. There is a single interior drain at the southwest corner of the roof. The condition of the roof is fair to poor, with leakage noted at the interior.

Pump house roof condition

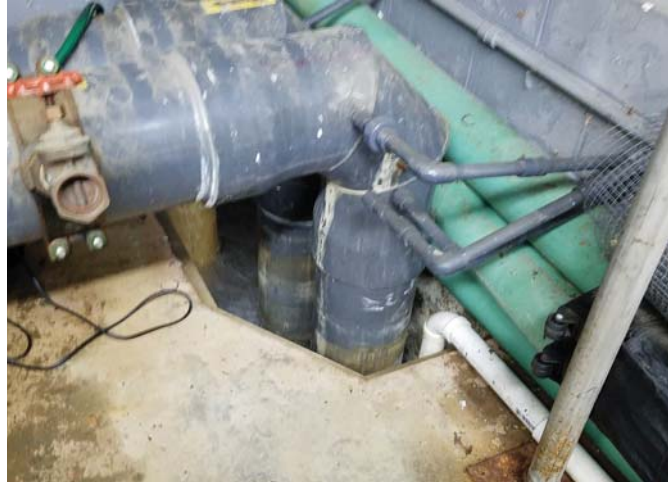
Interior flood condition with intake piping to swimming area

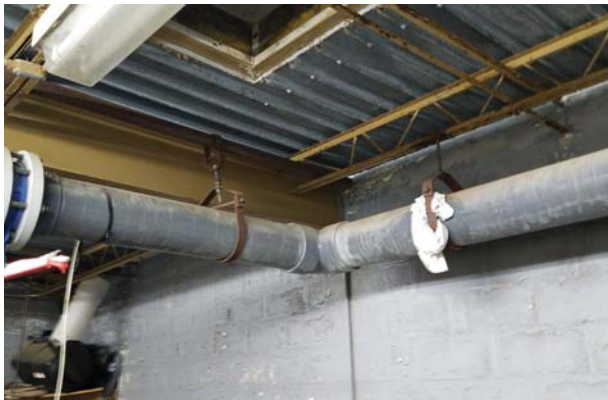
Flat roof interior with steel bar joists

The flat roof consists of metal roof deck supported by 8-inch deep steel bar joists. The steel bar joists are supported on a 12-inch wide flange beam at the center of the structure and 12-inch concrete masonry at the perimeter. The structure is constructed on shallow concrete foundations. Overall the structure is in fair condition. The existing metal roof deck has areas of corrosion. There is an unframed penetration through the roof for an exhaust fan. The steel bar joists and steel beam also have areas of corrosion. The concrete masonry walls show signs of deterioration from moisture intrusion vegetation growth. There are no signs of settlement of the structure.

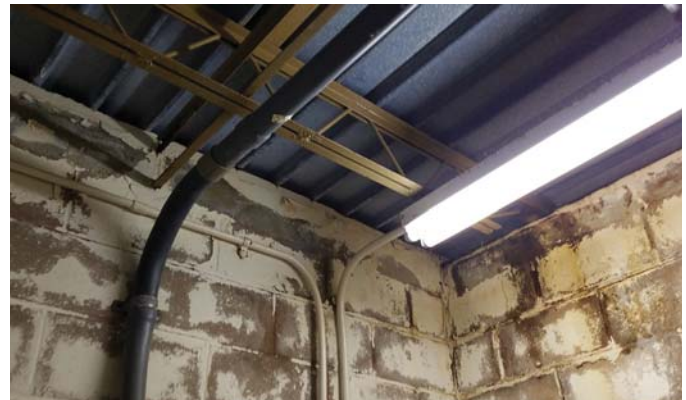
Walls - The 12-inch concrete masonry exterior walls appear to consist of an 8-inch interior CMU (concrete masonry unit) wythe with a 4-inch exterior split-face CMU block veneer. It is assumed that there is no insulation or drainage cavity in this wall assembly. The exterior masonry shows signs of deterioration from moisture intrusion and vegetation growth.

Walls showing interior CMU wythe

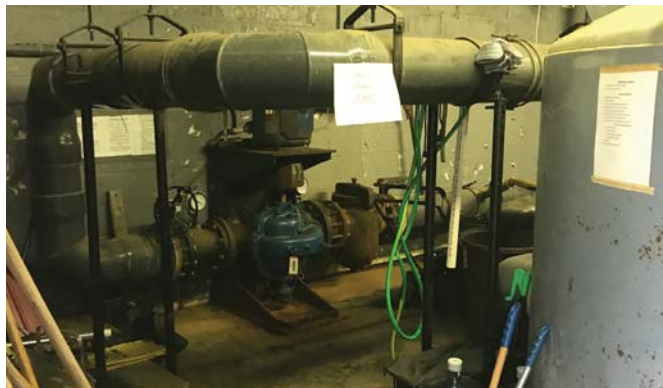
- The filter sand has not been changed in over ten years. The vessel is rusted. Operation has not been able to properly backwash the vessel and it is unknown how much sand is still in the filter.
- The pump is currently a vertically-mounted pump, however, it is a flood suction pump that is above the static water level, which makes it challenging to prime.
- The chemical controller no longer works and it doesn't appear to have worked for years.
- Instrumentation, such as flow meters and pressure gauges, do not function properly.
- The chemical injection system is not interlocked with the pump.
- The Town uses domestic water to supplement filling the swimming area when the water is too low.
- Site valves either do not open and operate or are difficult to operate.

Vertically-mounted Pump and Strainer

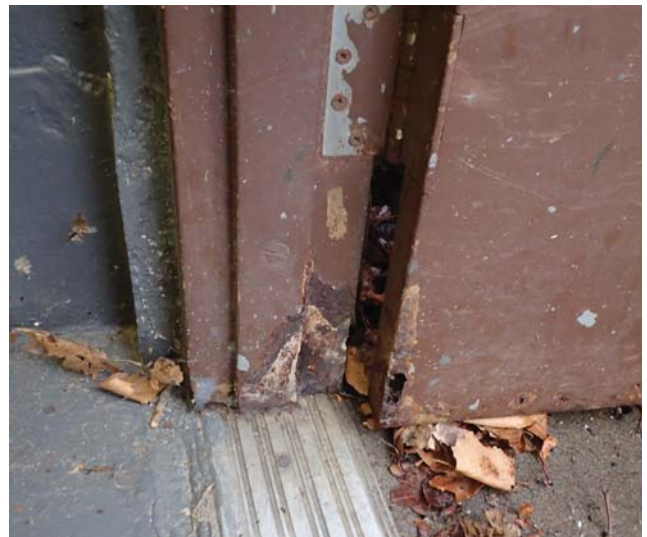
Typical door and frame condition at a restroom

For door openings, there are three single steel exterior doors. The doors and frames are showing some corrosion at their lower edges. Hardware operation was not verified. The doors and frames are not thermally broken. The presence or condition of weatherstripping was not verified.

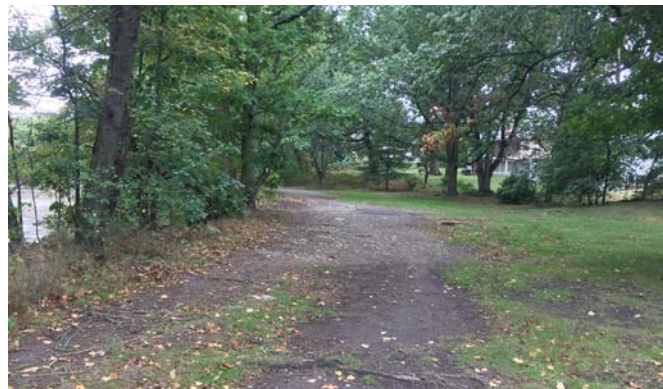
Ambiguous trail condition next to Rindge Park

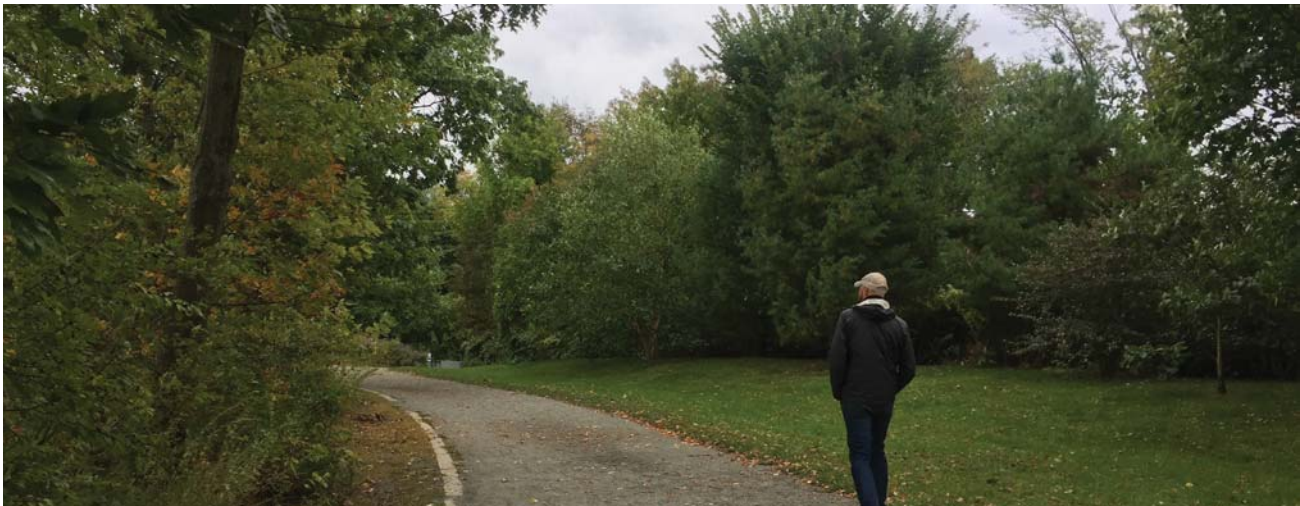
Trail condition near the Drake Village Complex

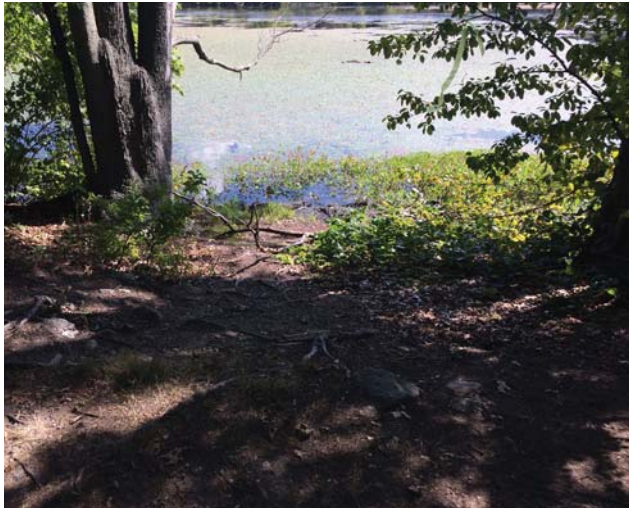
the park to access the water of the Res. The features are limited in extent and occur in isolated areas, therefore they are not caused by wave action. A few, especially near hard packed areas, may also be the result of stormwater runoff into the Res, which is most prevalent near the parking lot. There are also erosional conditions present around the existing stormwater outfalls, which are in disrepair.

Condition along the northern shoreline

In order to avoid further disturbance/erosion of these areas proper bank stabilization, resource area protection measures, and proper stormwater controls should be implemented. This would include curbing the parking lot to prevent water from running down the banks of the Res. Careful consideration should be made as to how to prevent further erosion from occurring in these and other areas, which will be discussed in the "Preferred Master Plan" section of this report.

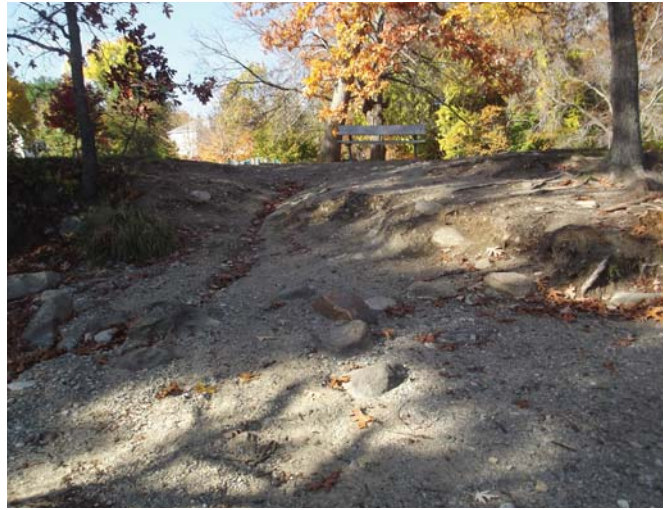
Condition at Rindge Park

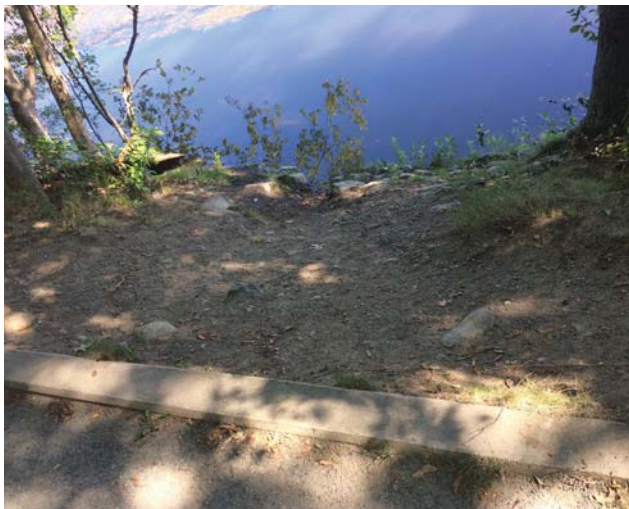
Condition along the southwestern shoreline

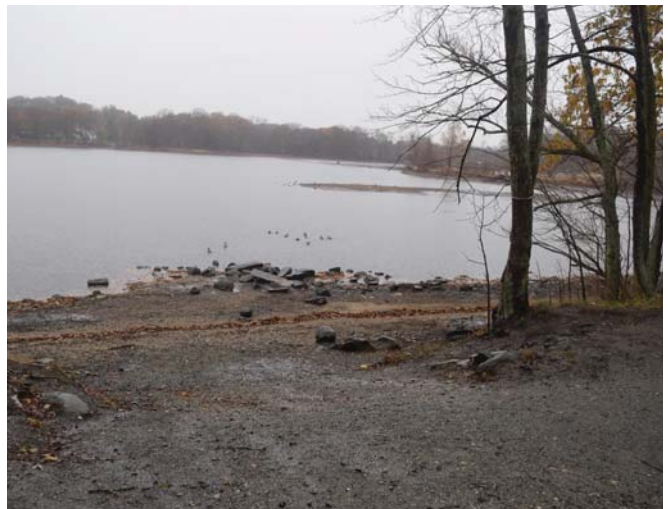
Condition along the southeastern shoreline

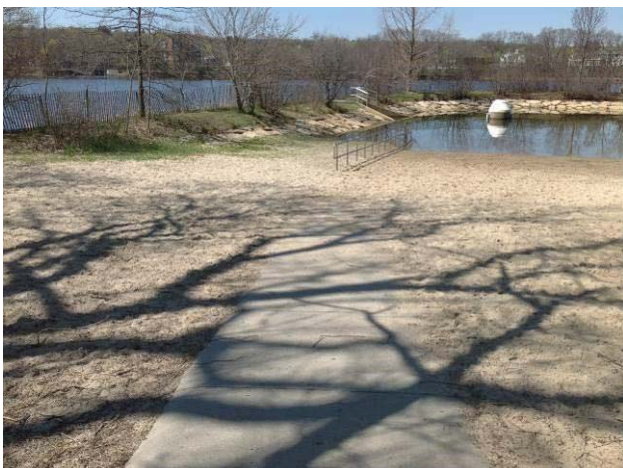
A sand path is provided along the entire facility. This path is not accessible because it is uneven and unstable, especially near benches and trees. Although a concrete walkway is provided near the water's edge, it is not connected to an accessible route.
